Installation Instructions

WR17X10424 - Bucket & Cover Assembly Display

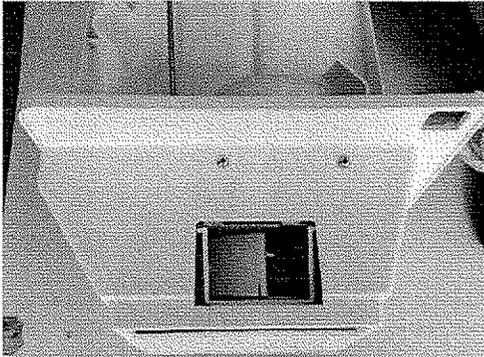
Two screws are located on the bottom of the Cover.

The Cover is easily removed from the assembly by removing four mounting screws. Those screw locations are the same on both Covers and shown in the photos below.

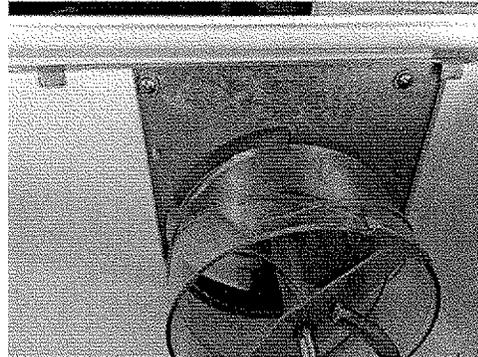
Two screws are located inside the Bucket, behind the Cover.

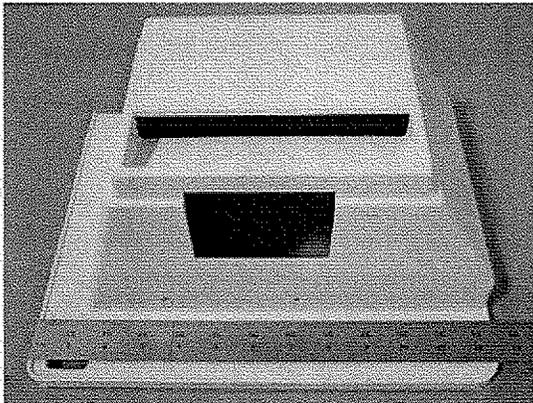
Cover to be removed and discarded
162D1305P002

When a recent change was made to Bucket & Cover Assembly Display WR17X10424 to use Cover 162D1305P002 instead of specified Cover 187D1768P001, interference with the Freezer Door closure was inadvertently introduced. To eliminate that interference, the Cover provided with the new Bucket Assembly must be removed, discarded and replaced by the Cover on the assembly being replaced.

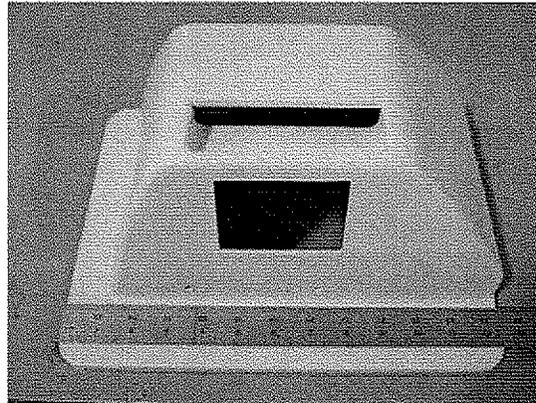
Original Cover 187D1768P001
